Inspection and maintenance guidance

For pre-finished steel building envelopes

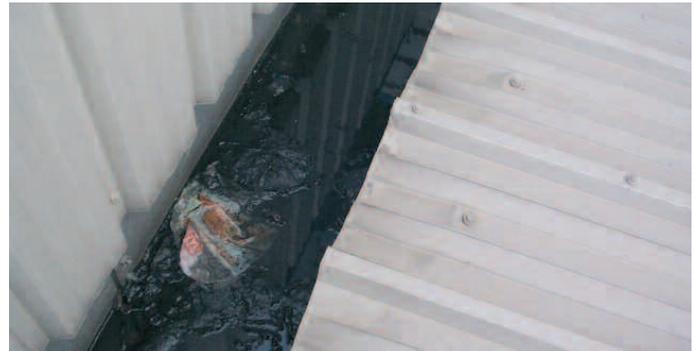
Build up of dirt in a gutter.

A build up of dirt and debris can occur on all surfaces, on all elevations and on roof cladding. Such build up will be particularly profound at any irregularity, such as at corners, penetrations and gutters. In some environments such as industrial estates and areas close to busy roads, dirt will build up more quickly than elsewhere. Rainfall will have a degree of washing effect. However, any area of the building sheltered from rain, for example, the top of roller doors, overhanging eaves or underneath photovoltaic panels, will not benefit from this natural cleaning effect.

Large quantities of debris can also lead to the overflowing or ponding of water, particularly in guttering, which may also lead to corrosion. To avoid this, debris should be swept into a pile, using a soft-bristled brush and removed. Shovels or hard tools should be avoided. All dirty areas should then be washed down using clean water. Do not use salt water or high pressure jets with a hose. If necessary use a recommended cleaning product, or a 10% solution of a good household or industrial detergent in water, before applying a final hose down with clean water. A soft-bristled brush can be used for particularly stubborn deposits.

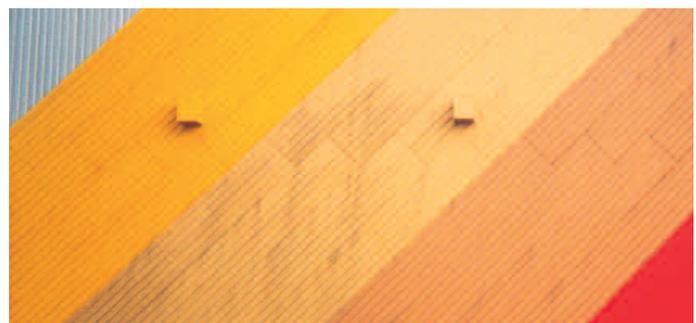
Dirt build up on cladding.

Cleaning should be carried out when dirt and debris are visibly apparent, not merely out of habit. The presence of dirt and debris not only affects the appearance, but may also lead to a breakdown of the coating. Furthermore, over many years, corrosion of the metal substrate may occur if a 'poultice' of debris, dirt, retained water and aggressive chemicals is allowed to build up.

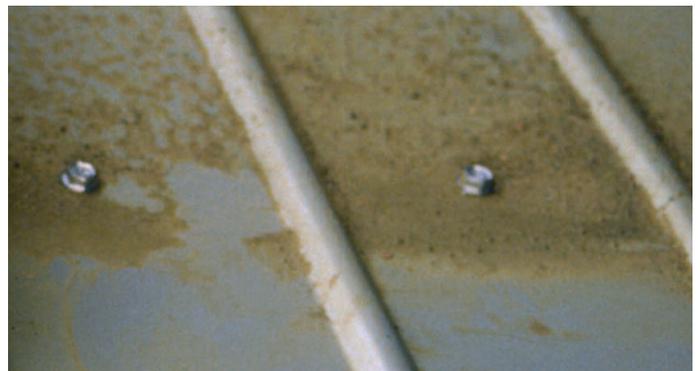
In general, fungi grow as a result of certain conditions, such as the presence of fungal spores, moisture and also of nutrients from various types of dirt. As with dirt and debris, fungal growth will not only affect the appearance, but can also lead to a breakdown of the coating and ultimately result in corrosion of the sheet. Washing the surface can remove fungal growth. A basic solution may be applied to a pre-washed surface by means of a low pressure spray or brush containing:

Mould growth on pre-finished steel cladding.

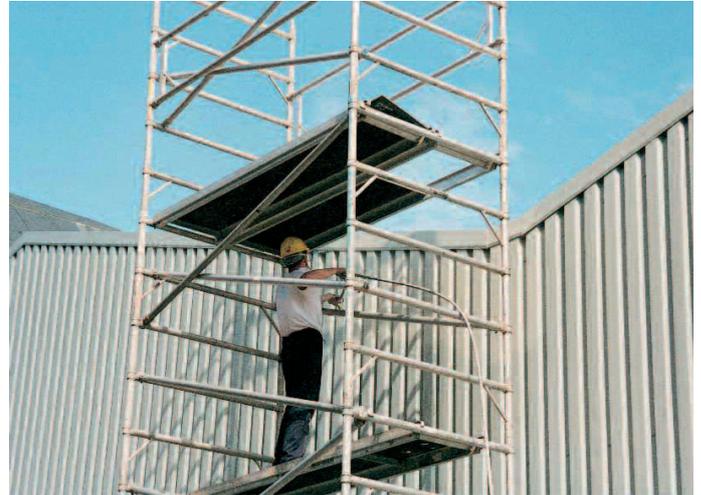
Caution must be exercised as over-painting is not simply a case of applying proprietary paint to the surface of the cladding. It is important that a compatible coating solution is defined and the use of an approved contractor will ensure correct application. Tata Steel can recommend appropriate over-paint solutions.

Wall cladding being over-painted.

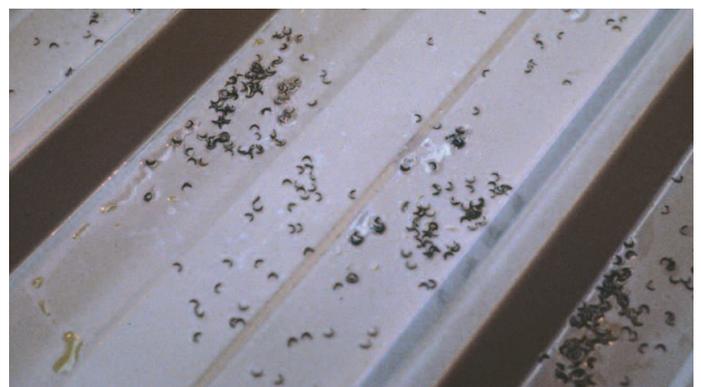
Metallic debris, such as swarf, rivet stems or other debris that may remain after construction or modification to the building will be vulnerable to corrosion, leading to an unsightly staining of the cladding. Debris of this nature should simply be removed at as early a stage as possible, carefully so as not to damage the underlying coating.

Swarf left on a roof.

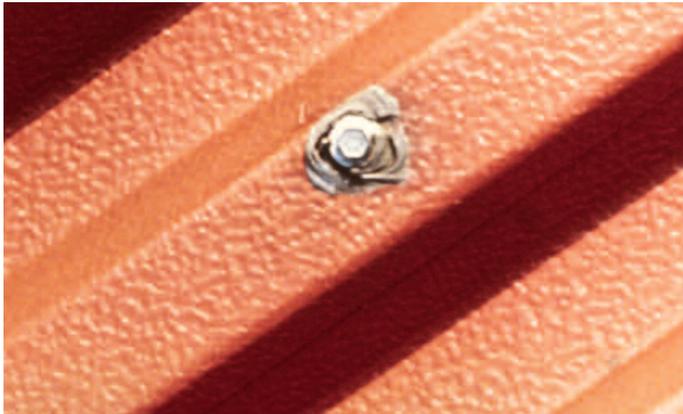
Fasteners which are faulty through damage or corrosion should be removed and replaced. Corrosion can lead to unsightly staining and potential corrosion of the cladding. Caps, if used, should be placed over uncovered fasteners, or replaced if damaged. Inappropriate fasteners of incorrect material or design should also be replaced as again they could lead to corrosion of the panels.

Damaged fastener on roof cladding.

| Check for | Action |
|---|---|
| Faulty fasteners | Replace the fasteners and any missing caps. |

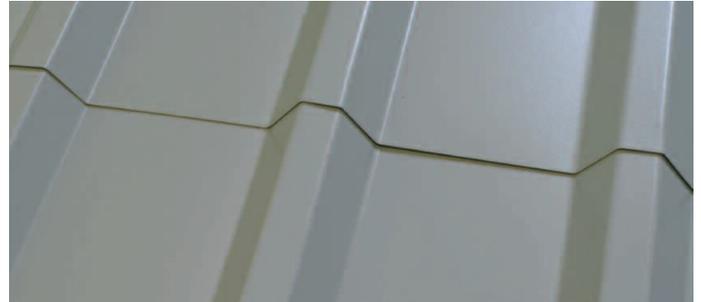
A cut edge is an area of exposed substrate where a pre-finished steel cladding sheet has been cut. All exposed, site cut edges must be produced to an optimum standard. Where it is not possible to protect the site cut edge from weathering by a cover flashing, they should be treated with a suitable edge protection paint or lacquer. The requirement for this sort of protection is particularly important in:

Cut edge on roof cladding.

Burrs at cut edges should be minimised by effective shearing practice. Where possible the down burr edges should be on the down slope edge of the roof pitch.

On damaged edges, remedial treatment is achieved by abrading back the effects of corrosion and then applying a suitable primer and topcoat to match the colour of the existing cladding.
